CAA Inspection Report

Inspection Date(s): July 17, 2018

Facility Name: Tallaboa Industrial Park

Asbestos NESHAP – 40 CFR 61 Subpart M

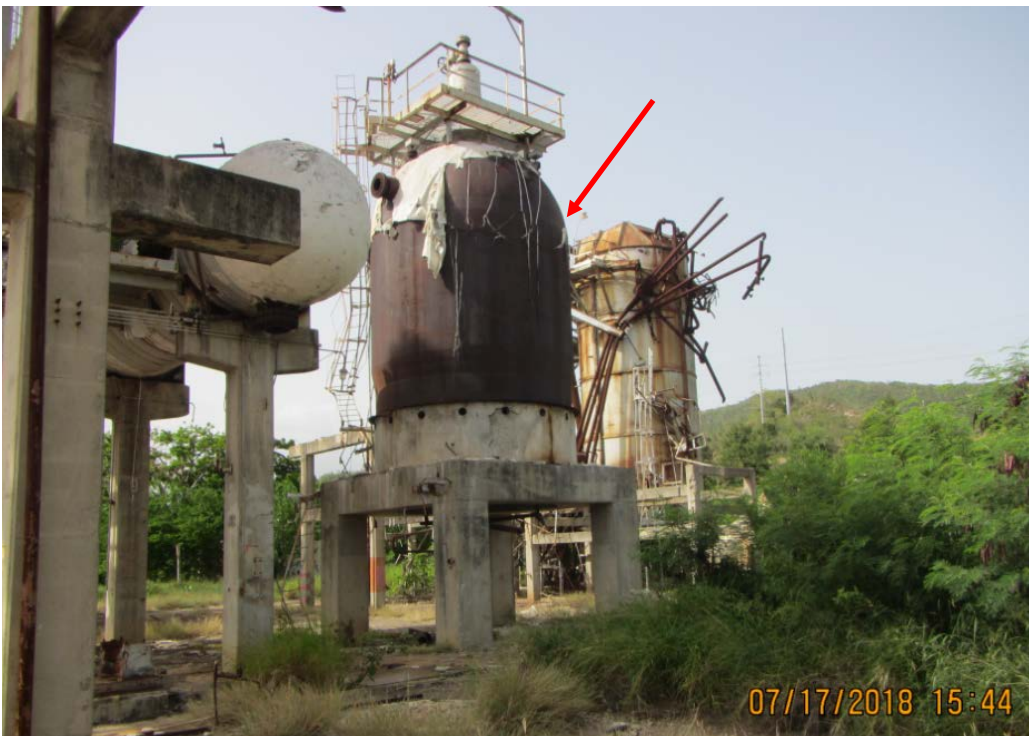
Figure 37, Structure with cloth lagging hanging on the top of it. Pieces of insulation material appears to have fallen around it. There was less insulation debris on the ground and concrete rack than what would be expected if from a structure of this size.

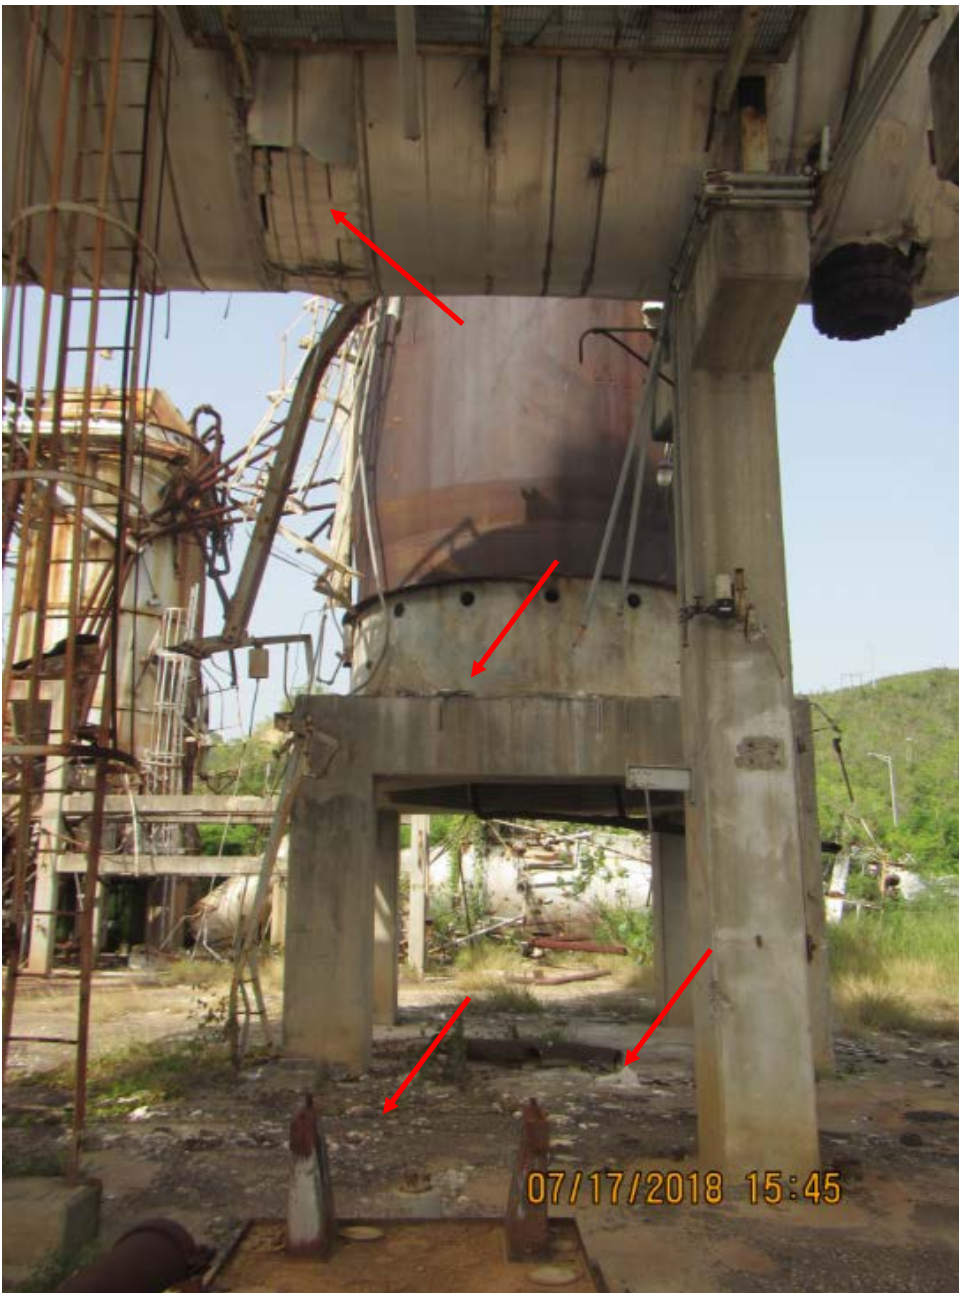
Figure 38, Closer image of the structure in figure 37. Spots of insulation material was noted, but large accumulation of insulation not observed.

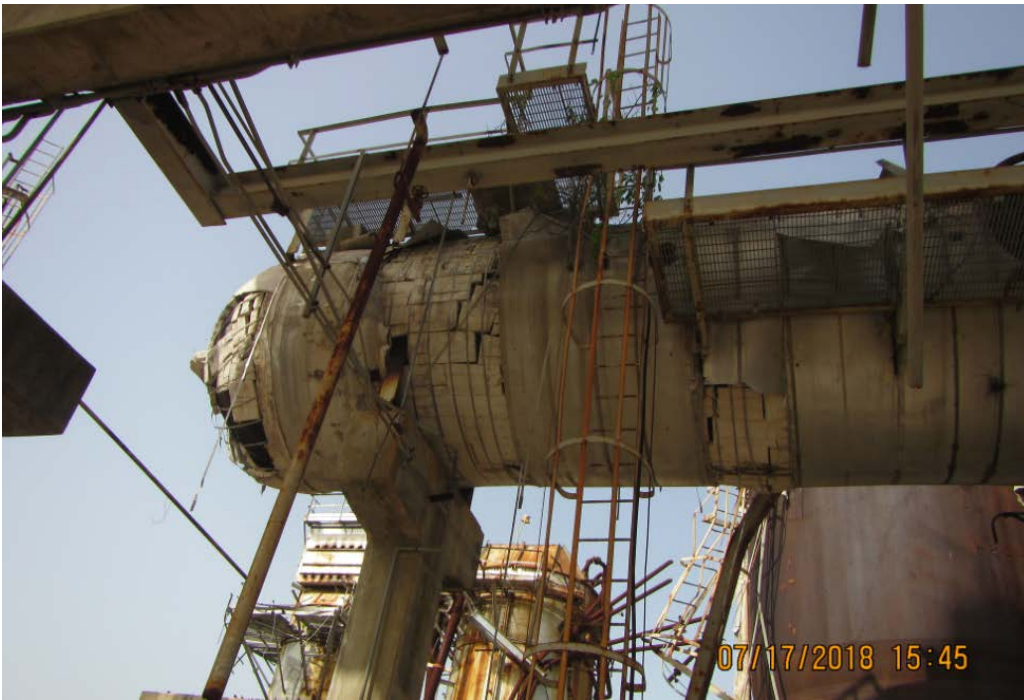
Figure 39, Image of a tank next to the structure in figure 38. The protective cladding on approximately half the structure is missing, exposing the white insulating material to the element. A portion of the insulation material have fallen off the structure.

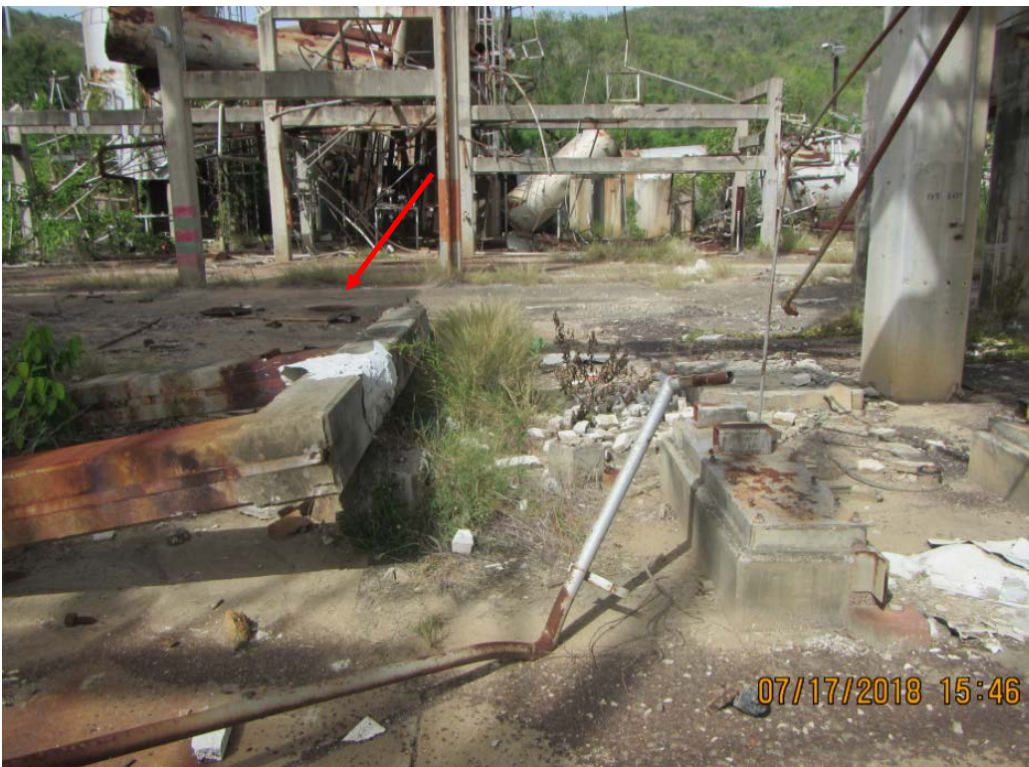
Figure 40, Bottom of the structure in figure 39. Insulation material was found under the structure along with lagging material. In the back of the picture, we see a manhole that was open at the time of the inspection. Homeca staff stated that the Superfund asked that they keep the manhole open.

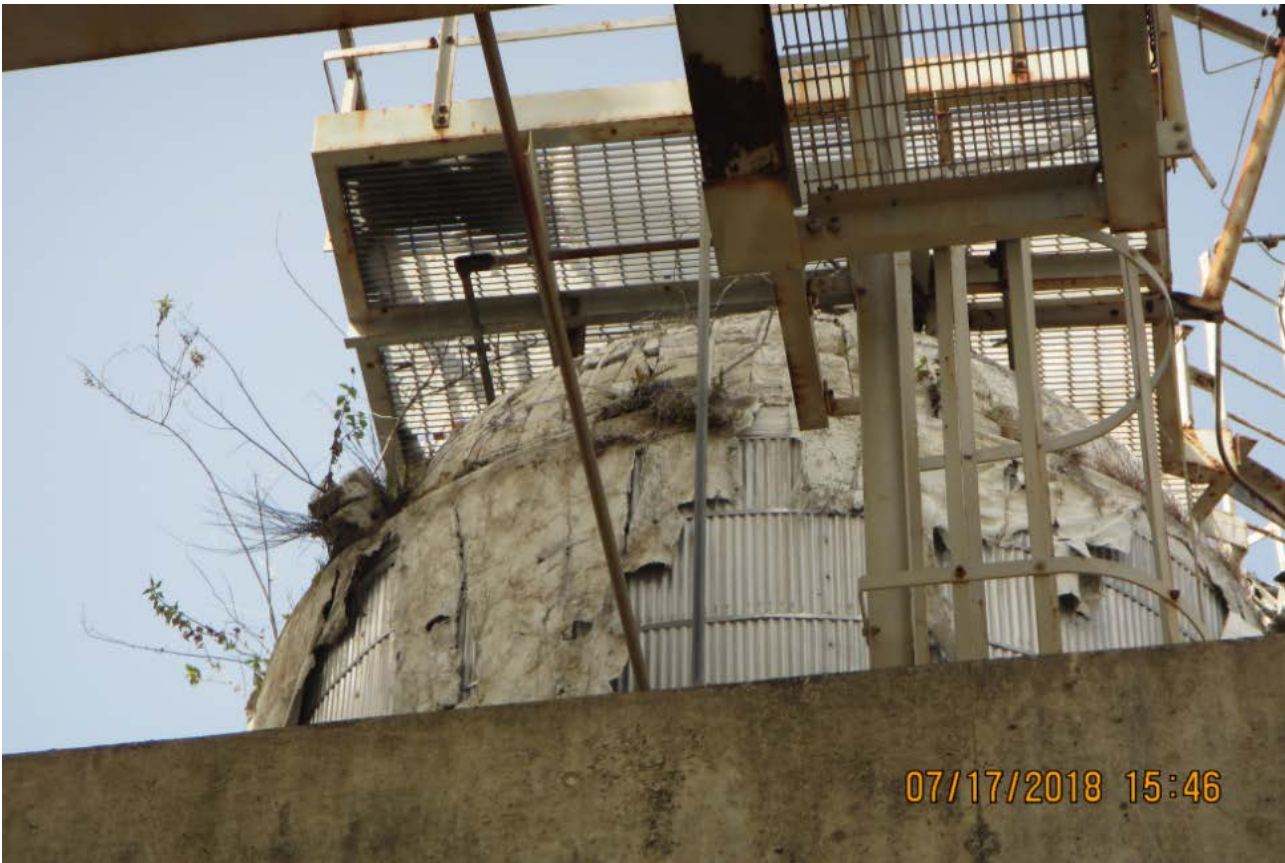
Figure 41, Bottom of another structure in this area where the lagging has deteriorated and exposed insulation material on the top.

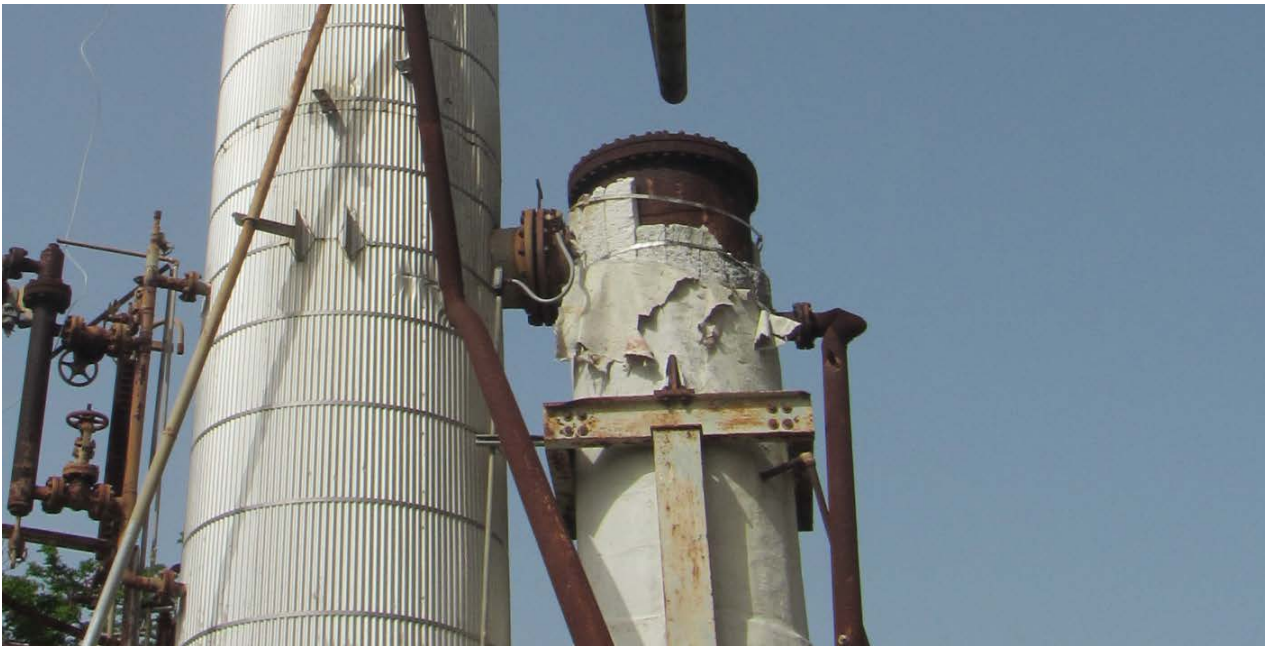
Figure 42, Two columns at the end of the work area. There appears to be some damage to the insulation material and part of pipe attached to one of the column appears to be partially missing.

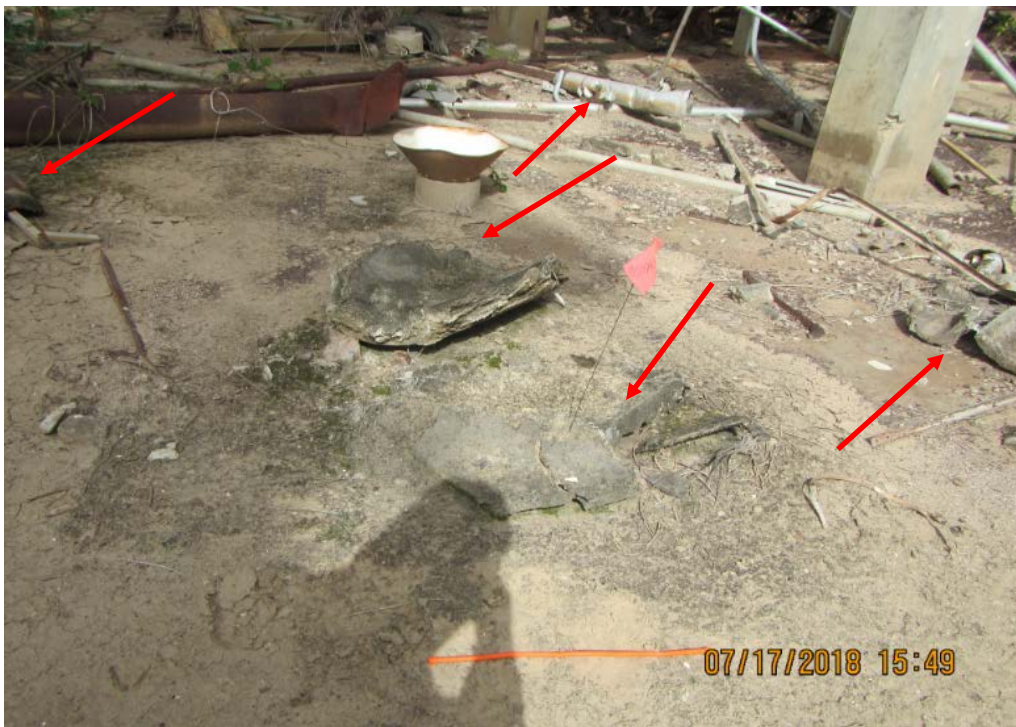
Figure 43, Under these two structures in figure 42, there was debris scattered throughout the area. Pipes were scattered throughout the area, some with insulation still attached.

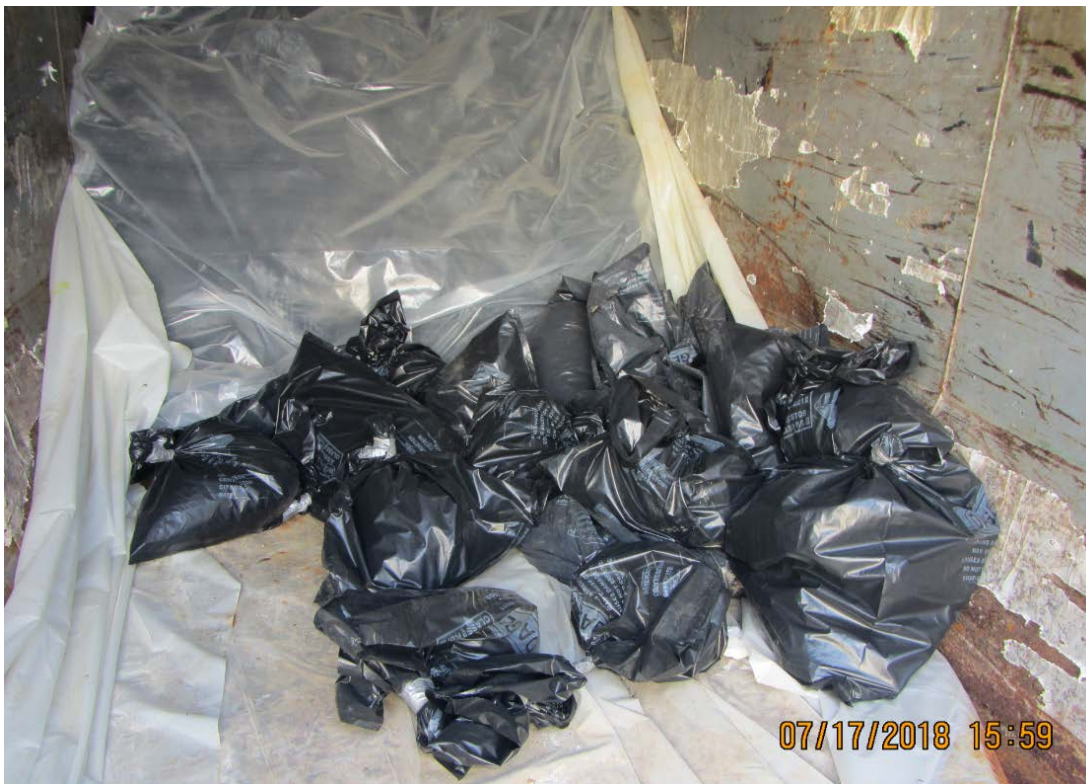
Figure 45, Inside of the container. The container only appears to be less than half full.

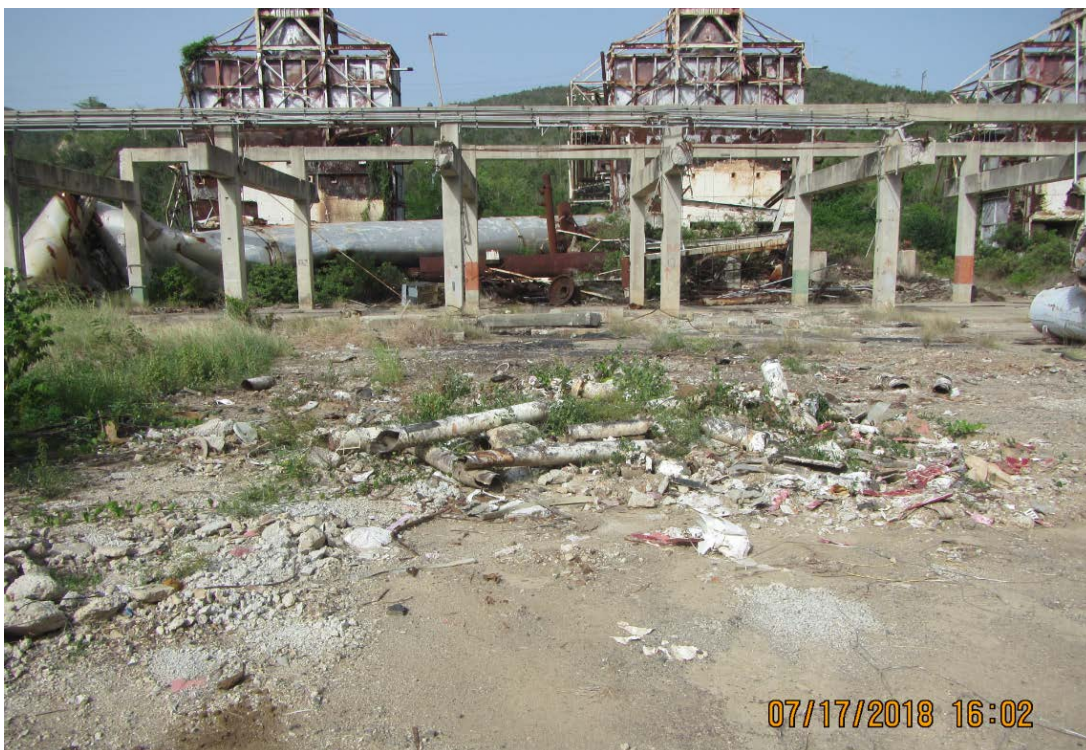
Figure 47, In the area where the metal pile was recently removed. Note that the white material is consistent with insulation material found scattered throughout the site. There were numerous pipe insulation jackets.

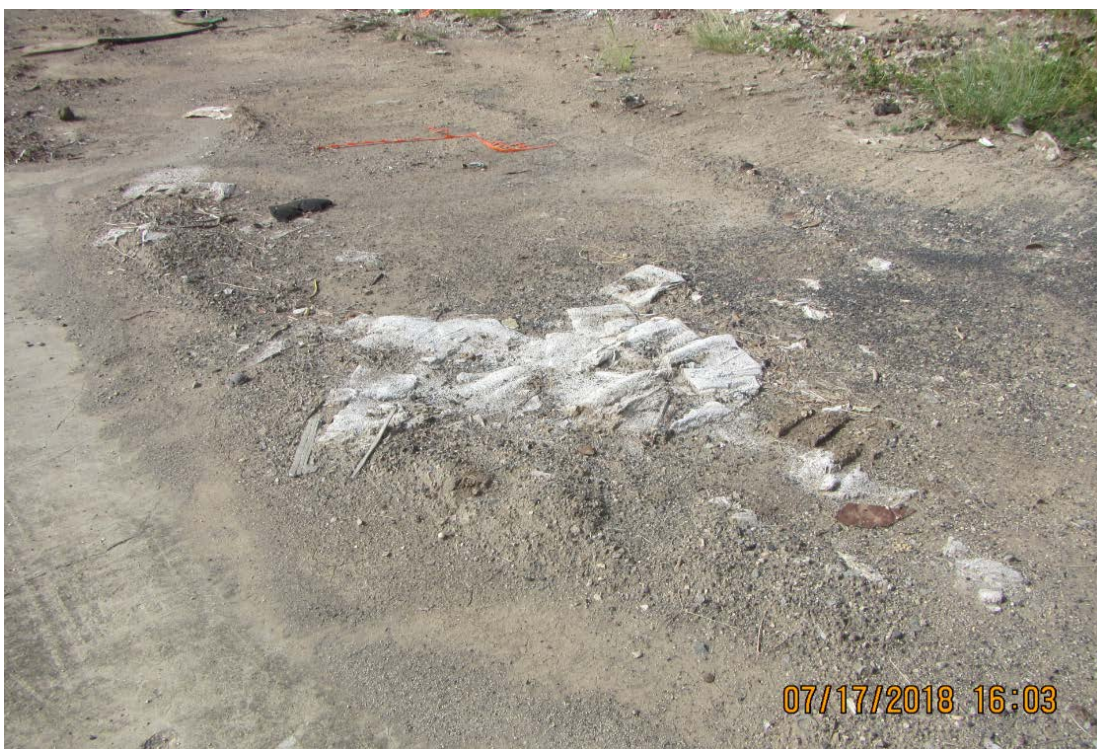
On the way back to the decontamination station, the inspector walked past an open area where metal piles were previously stationed for recycling. At the time of the inspection, most of the metal have been removed. At this location, the inspector observed debris that resembled pipe insulation, pipe lagging, metal pipes, and other construction debris (see figure 47). A few steps away from the debris seen in figure 47, it appears that lagging and pipe insulation was ran over by construction vehicles (see figure 48).

Figure 48, Lagging and pipe insulation that appears to be run over by construction vehicles.
